**Flood Control Project Maintenance  
Levee Inspections**  
**LMA District Cover Sheet**  
**Spring 2018 Levee Inspection Results**

**Reclamation District No. 1001 Nicolaus**

**Spring 2018 Levee Inspection Results**

| Waterway | | | Bank | Unit Miles |
|--|---|---|---|---|
| Unit No. 01 Yankee Slough | | | Right | 4.12 |

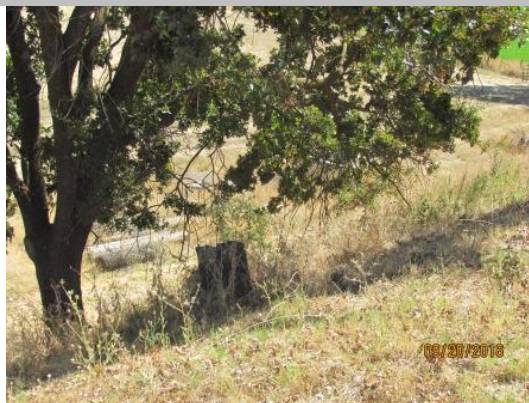
Photo 1 of 1 : SP\_2018\_RD1001\_38\_21\_20180302\_00013.jpg

View of a stump in the landside levee slope. Fall 2016.

| Remove stump from the landside levee slope. | | | | | |

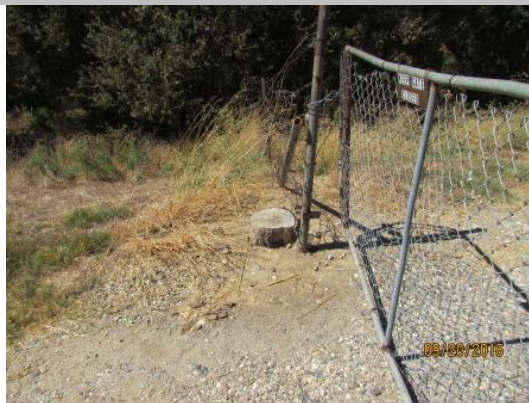
Photo 1 of 1 : SP\_2018\_RD1001\_38\_60\_20180302\_00046.jpg

View of tree stump, waterside crown at gate. Fall 2016.

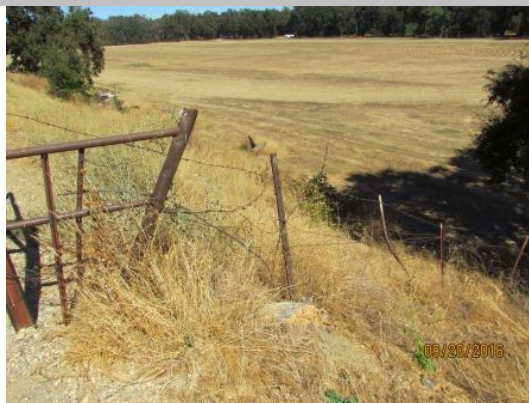
Photo 1 of 1 : SP\_2018\_RD1001\_38\_61\_20180302\_00047.jpg

View of tree stump, landside crown at gate. Fall 2016.

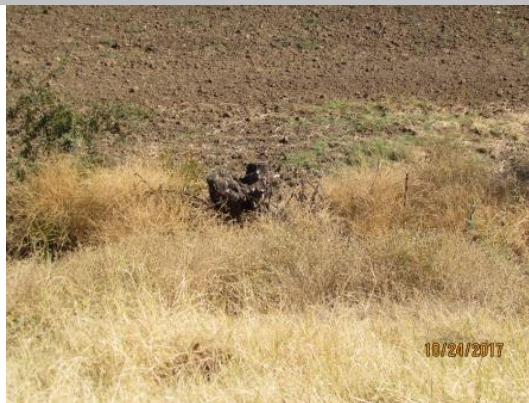
Photo 1 of 1 : SP\_2018\_RD1001\_38\_69\_20180302\_00057.jpg

View of landside toe of a stump that needs to be removed, Fall 2017.

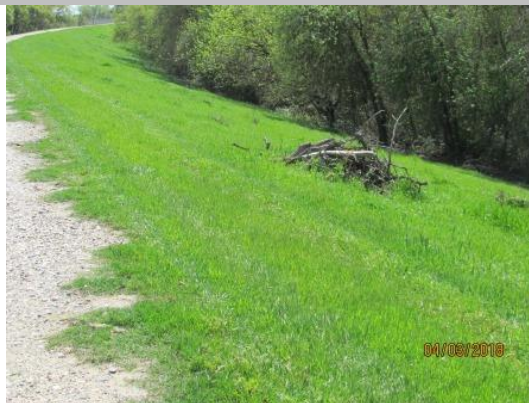
Photo 1 of 2 : SP\_2018\_RD1001\_38\_67\_20180411\_00092.jpg

View looking downstream waterside of pruning's on the levee slope, Spring 2018.

| Remove pruning's from levee slope, Spring 2018. | | | | | |

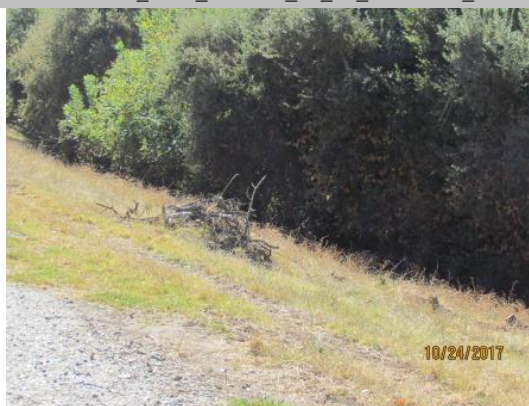
Photo 2 of 2 : SP\_2018\_RD1001\_38\_67\_20180302\_00055.jpg

View looking downstream waterside of pruning's on the levee slope, Fall 2017.

| Remove pruning's from levee slope, Spring 2018. | | | | | | |

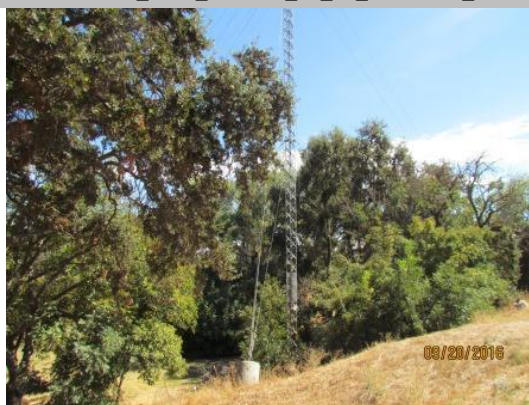
Photo 1 of 1 : SP\_2018\_RD1001\_38\_19\_20180302\_00011.jpg

View of power pole and guy wire on the levee slope. Fall 2016.

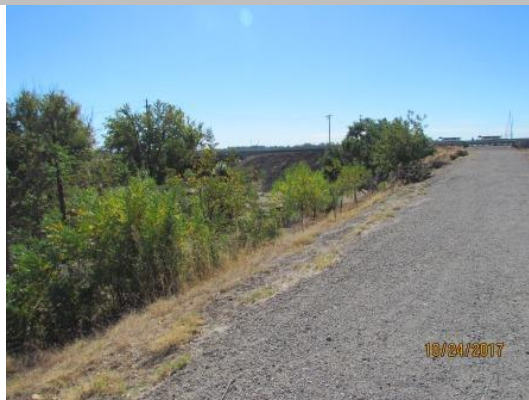
Photo 2 of 2 : SP\_2018\_RD1001\_38\_48\_20180302\_00036.jpg

View looking downstream of fence and landscaping that has been placed by the land owner on levee slope and needs to be removed, Fall 2017.

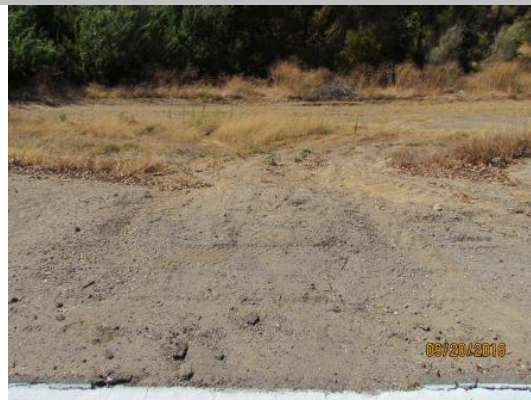
Photo 2 of 2 : SP\_2018\_RD1001\_38\_78\_20180302\_00060.jpg

Ruts still there on waterside slope due to vehicles. Fall 2016.

| S3 : Repair the levee slope damaged by vehicle traffic and prevent access where possible. | | | | | | |
| Repair damage on slope cause by vehicle traffic, Fall 2017. | | | | | | |

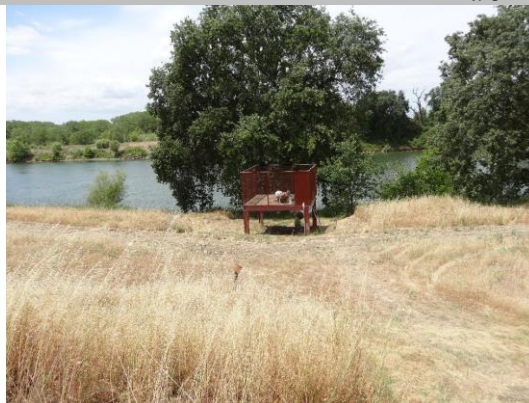
Photo 1 of 3 : UCIP\_SP\_2018\_14604\_24107.jpg

| FS_ID:14604<br>DS_ID:22573<br>EP_NO: 10389<br>Repair Type: Non-Urgent<br>Crossing Status: Found<br>UCIP Comments: - water leakage causes erosion on LS slope.- may be pressure breaker valve not closed properly on LS.- a 36-inch concrete standpipe at the landward toe not found.<br>FIELD_STRUCT_DESC: *REPLACEMENT* 12-inch irrigation discharge pipe of an unknown material through the levee, 10 feet below the crown. 30-horsepower slant pump on the riverbank. Siphon breaker in a 24-inch corrugated metal pipe (CMP) riser on the landside (LS) slope. Pipe discharges into a 36-inch concrete standpipe at the LS toe. Pipe installed by USACE in 1963. Switch panel and service pole at the LS toe. (Replacement of a 12-inch pipe and a 30-horsepower slant pump authorized under Permit No. 10389, 1974 - Pluma Orchards).<br>[Additional Reference(s): DWR Levee Log, 1993].<br>FS Date: 5/16/2013 | | | | | |

WS- slanted pump station on steel platform on levee berm.

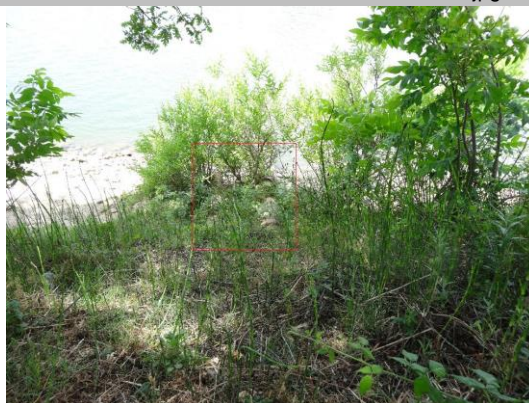
Photo 2 of 3 : UCIP\_SP\_2018\_14604\_24106.jpg

WS- inlet pipe on the river bank.

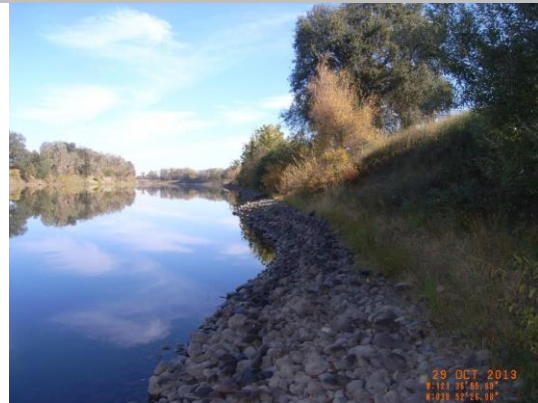
Photo 1 of 1 : SP\_2018\_RD1001\_38\_2\_20180302\_00002.jpg

| 2011 - Erosion pockets from tree popouts. Sections of the lower bank have slumped off. 2013 - Scallops from tree popouts no longer visible on site. Minor new erosion at the middle of the bank. 2015: Fresh erosion from human use. [2015 Site ID: FHR_6-6_L] | | | | | |

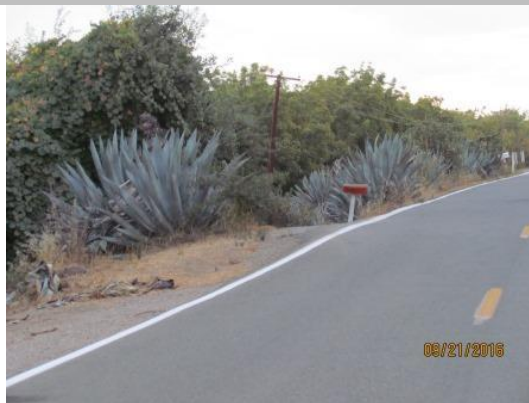
Photo 1 of 1 : SP\_2018\_RD1001\_38\_17\_20180302\_00010.jpg

View of landscaping on the landside shoulder and slope looking downstream. Fall 2016.

| Home owners landscaping should be removed, Spring 2018. | | | | | |

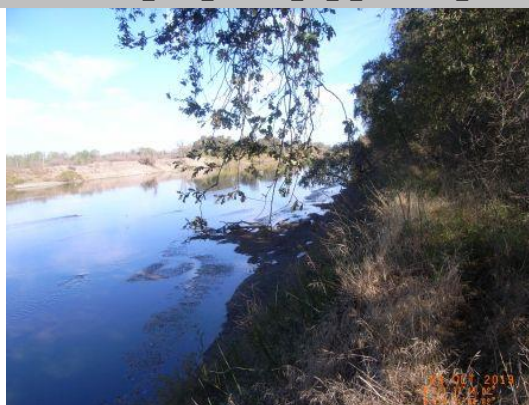
Photo 1 of 1 : SP\_2018\_RD1001\_38\_5\_20180302\_00005.jpg

| 2011 - Tall slumping sections. Scour around trees has exposed most of the roots. 2015: Recent large slope failure observed. [2015 Site ID: FHR_6-0_L] | | | | | |

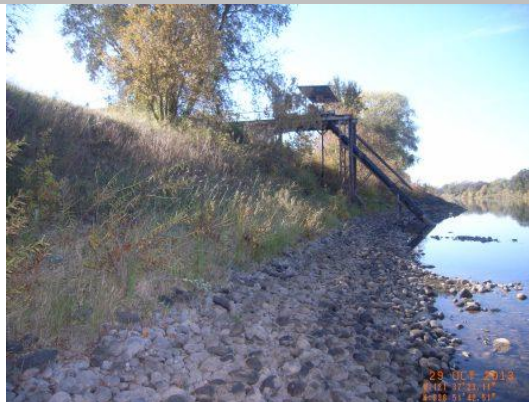
Photo 1 of 1 : SP\_2018\_RD1001\_38\_4\_20180302\_00004.jpg

| 2011 - Large slumped sections on the lower bank. 2012 - New cracks observed. 2015: No observed changes. [2015 Site ID: FHR_5-8_L] | | | | | |

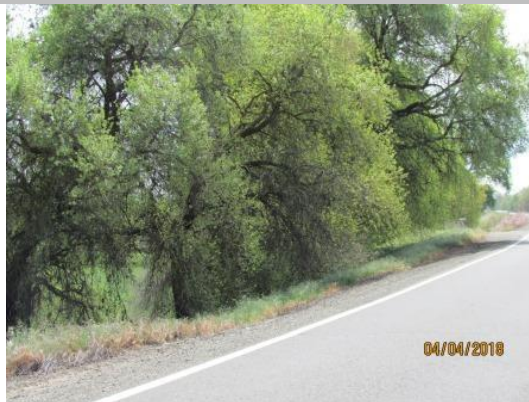
Photo 1 of 1 : SP\_2018\_RD1001\_38\_45\_20180411\_00098.jpg

View looking downstream landside of trees that need limbs trimmed for access and visibility, Spring 2018.

| Trim limbs for access and visibility, Spring 2018. | | | | | |

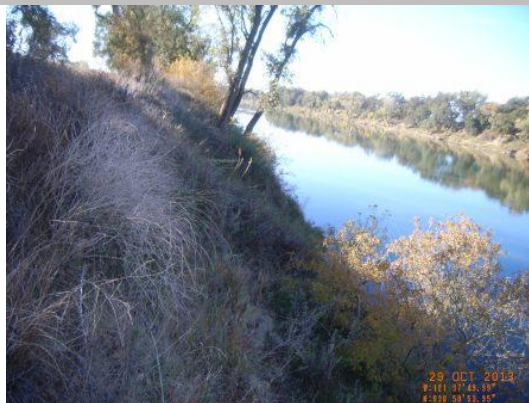
Photo 1 of 1 : SP\_2018\_RD1001\_38\_8\_20180302\_00008.jpg

| 2000 - Steep bank off berm with some slumps and fallen trees, continued erosion. 2002 - Site lengthened upstream and downstream due to vertical bank along most of the reach. 2010 - Site extended upstream. 2011 - Minimal new erosion. 2012 - Site extended on the upstream end, new tree pop-out, and bank erosion continues to worsen. 2013 - Minor new erosion at the toe and top of bank. 2015: No observed changes. [2015 Site ID: FHR_5-0_L] | | | | | | |

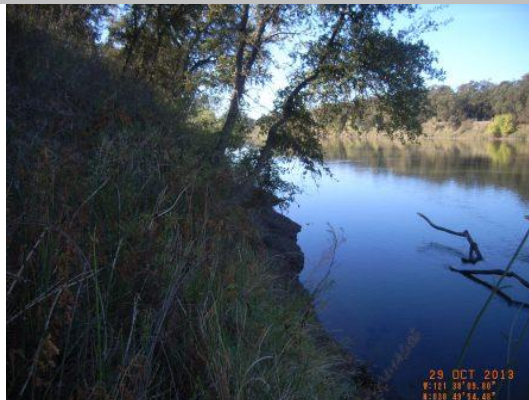
Photo 1 of 1 : SP\_2018\_RD1001\_38\_7\_20180302\_00007.jpg

| 2006 - Sandy, silty bank with intermittent pockets of erosion. Rotational failure and tree pop outs are most of the problem. Some upper slope fluvial erosion. 2010 - Site extended upstream. The lower Feather may benefit from a regional repair. 2011 - Site combined with 3.6. Minimal new erosion. 2013 - New erosion observed at bank toe. Trees on site now have exposed roots. 2015: No observed changes. [2015 Site ID: FHR_3-8_L] | | | | | |

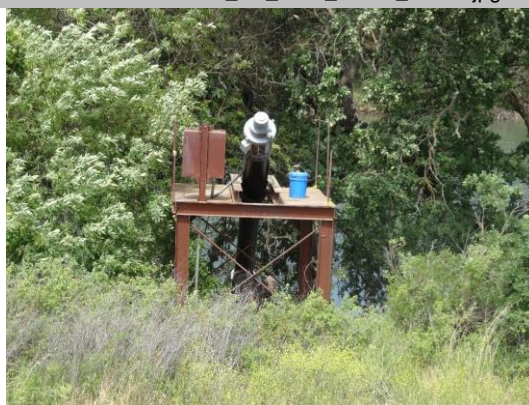
Photo 1 of 3 : UCIP\_SP\_2018\_14563\_24002.jpg

| FS_ID:14563<br>DS_ID:22577<br>EP_NO: 12828<br>Repair Type: Non-Urgent<br>Crossing Status: Found<br>UCIP Comments: - needs detailed investigation for road surface cracks<br>FIELD_STRUCT_DESC: 16-inch asphalt coated steel irrigation discharge pipe through the levee, 4.3 feet below the crown. 30-horsepower slant pump and platform on the riverbank. (16-inch irrigation discharge pipe and 30-horsepower slant pump authorized under Permit No. 12828, 1979. It is assumed that this 16-inch pipe replaces the abandoned 10-inch steel pipe referenced in the O&M Manual). [Additional Reference(s): DWR Levee Log, 1993. USACE Sacramento O&M Manual 141.1, August 1955, (RM 3.3), abandoned 10-inch steel pipe referenced].<br>FS Date: 5/16/2013 | | | | | |

WS- slanted pipe in steel structure on river bank.

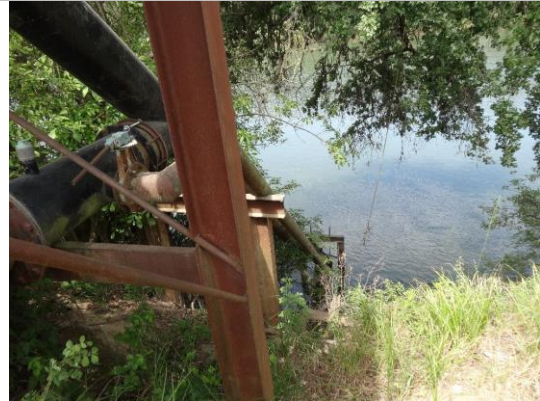
WS- inlet pipe and main pipe in pump station on river bank.

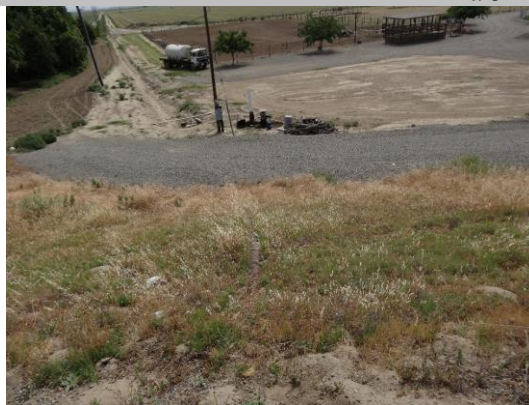
Photo 3 of 3 : UCIP\_SP\_2018\_14544\_23964.jpg

| UCIP Comments: - seems abandoned pipe crossing.- needs properly abandoned.- a 48" steel tank not found on landside. | | | | | | |

LS- overview of landside, steel pipe on levee slope.

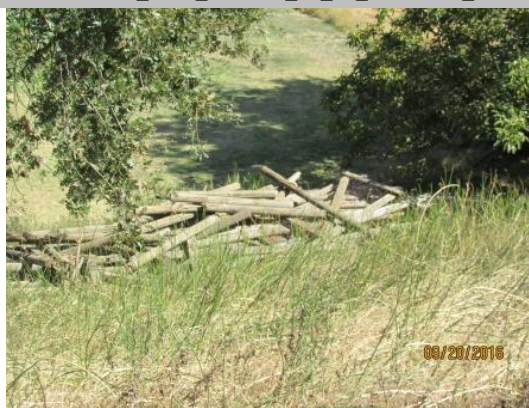
Photo 1 of 1 : SP\_2018\_RD1001\_38\_82\_20180302\_00062.jpg

| Old fence post pile at landside levee toe, Spring 2018. | | | | | |

View of a pile of fence post at the landside levee toe. Fall 2016.

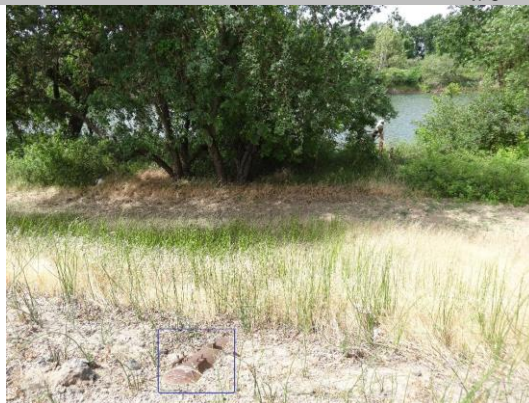
Photo 1 of 3 : UCIP\_SP\_2018\_14627\_24134.jpg

| FS_ID:14627<br>DS_ID:22578<br>EP_NO: 3297<br>Repair Type: Non-Urgent<br>Crossing Status: Found<br>UCIP Comments: - needs properly abandoned.- dismantled standpipe found on LS levee slope<br>FIELD_STRUCT_DESC: 12-inch steel irrigation discharge pipe through the levee, 3 feet below the crown. Slant pump mounted on a steel structure on the riverbank. Siphon breaker on the landside (LS) shoulder. Pipe discharges into a 24-inch concrete standpipe at the LS toe. (Pipe and pump authorized under Permit No. 3297, 1960 - Albert Linggi). [Additional Reference(s): DWR Levee Log, 1993].<br>FS Date: 5/16/2013 | | | | | |

WS- exposed pipe on levee slope and pump station in river bank.

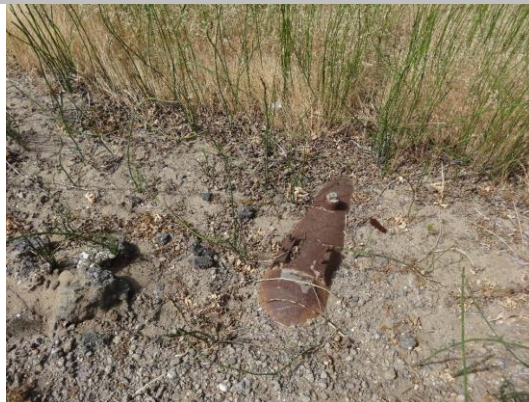
Photo 2 of 3 : UCIP\_SP\_2018\_14627\_24133.jpg

WS- exposed pipe on levee slope.

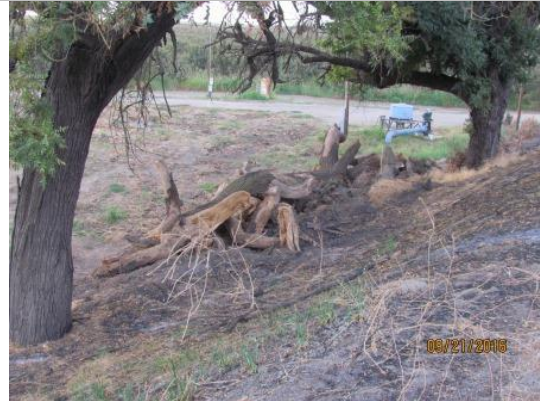
Photo 2 of 2 : SP\_2018\_RD1001\_38\_66\_20180302\_00054.jpg

| Downed tree pushed up to levee toe needs to be removed, Fall 2017. | | | | | | |

View of large tree pushed up to the landside levee toe. Fall 2016.

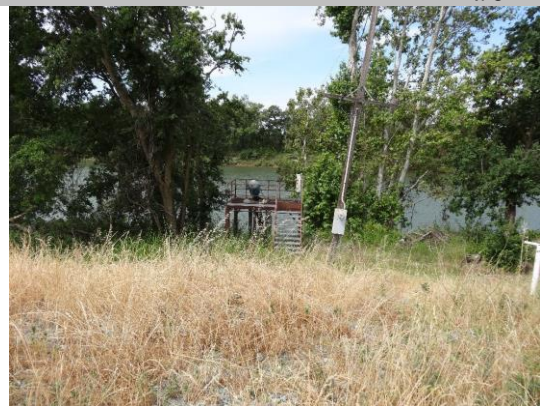
Photo 1 of 3 : UCIP\_SP\_2018\_41723\_23977.jpg

| FS_ID:41723<br>DS_ID:22572<br>EP_NO: 1881<br>Repair Type: Non-Urgent<br>Crossing Status: Found<br>UCIP Comments: - buried slide gate found on WS slope.- concrete box at the landward toe not found.<br>FIELD_STRUCT_DESC: 18-inch steel irrigation discharge pipe through the levee, 5 feet below the crown. Slant pump mounted on a pile structure on the riverbank. Gate valve on the waterside (WS) slope. Siphon breaker on the landside (LS) shoulder. Pipe discharges into a concrete box at the LS toe. (18-inch steel discharge pipe and slant pump authorized under Permit No. 1881, 1954 - L. G. Kipp and R. B. Reith). [Additional Reference(s): DWR Levee Log, 1993].<br>FS Date: 5/16/2013 | | | | | | |

WS- slant pump on steel structure in river bank.

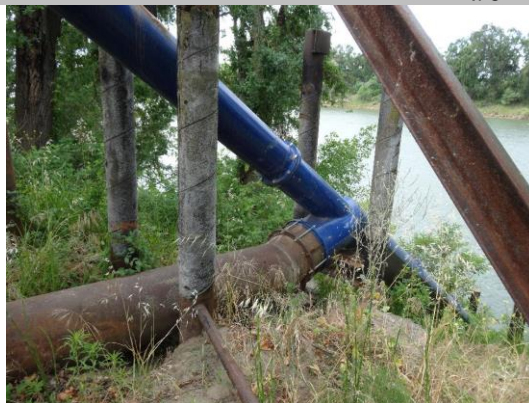
Photo 2 of 3 : UCIP\_SP\_2018\_41723\_23976.jpg

WS- main steel pipe on levee surface (without paint).

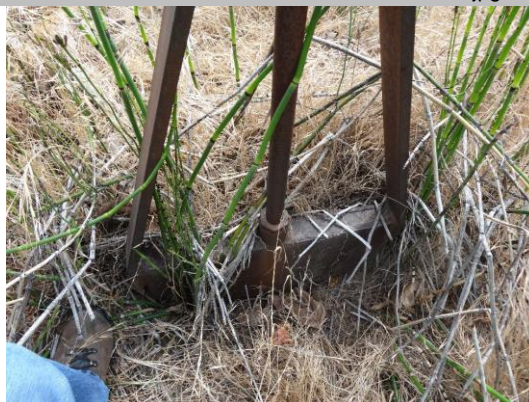
Photo 3 of 3 : UCIP\_SP\_2018\_41723\_23978.jpg

WS- gate valve on levee slope.

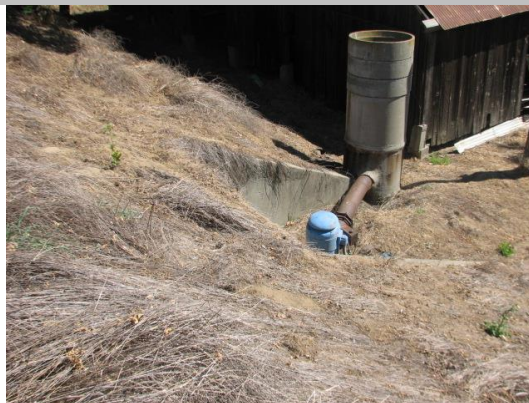
Photo 1 of 1 : SP\_2018\_RD1001\_38\_30\_20180302\_00018.jpg

A retaining wall is within the profile of the slope. Spring 2013

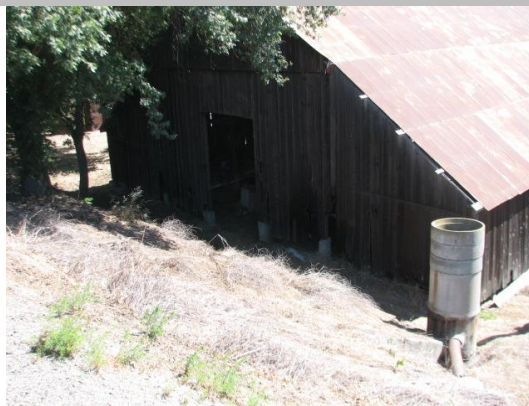
Photo 1 of 1 : SP\_2018\_RD1001\_38\_29\_20180302\_00017.jpg

The building is within the easement of the levee. Spring 2013

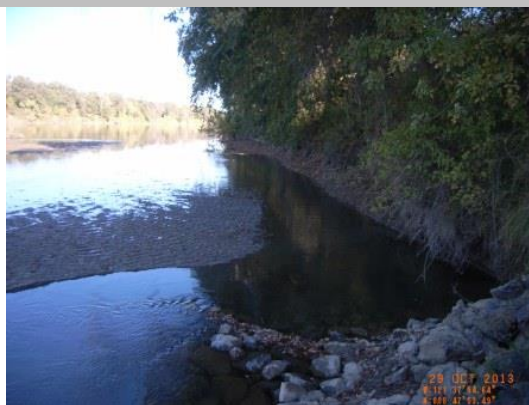
Photo 1 of 1 : SP\_2018\_RD1001\_38\_6\_20180302\_00006.jpg

| 2000 - Site is relatively stable except for some toe erosion at the upstream end, recommend monitoring the upstream end. 2004 - Some new block failures (10ft deep) at the toe of the upstream end. 2007 - Some minor new slumping at the waterline. 2013 - Minor new erosion along the bank toe. 2015: No observed changes. [2015 Site ID: FHR_1-0_L] | | | | | |

USACE 2013 Photo #1

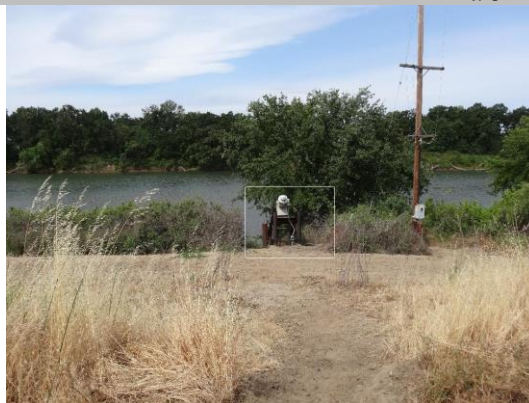
Photo 1 of 3 : UCIP\_SP\_2018\_14548\_23970.jpg

| FS_ID:14548<br>DS_ID:22580<br>EP_NO: 3489<br>Repair Type: Non-Urgent<br>Crossing Status: Found<br>UCIP Comments: - siphon breaker on the landward shoulder not found.- cracked road surface along the pipe alienment. Needs more investigations.<br>FIELD_STRUCT_DESC: 16-inch irrigation discharge pipe of an unknown material through the levee, 3 feet below the crown. 40-horsepower slant pump mounted on a steel structure on the riverbank. Pipe discharges into a 36-inch concrete standpipe at the landside (LS) toe. (Pipe and 40-horsepower pump authorized under Permit No. 3489, 1960 - Kirtland Brothers). [Additional Reference(s): DWR Levee Log, 1993].<br>FS Date: 5/16/2013 | | | | | |

WS- slant pump on river bank.

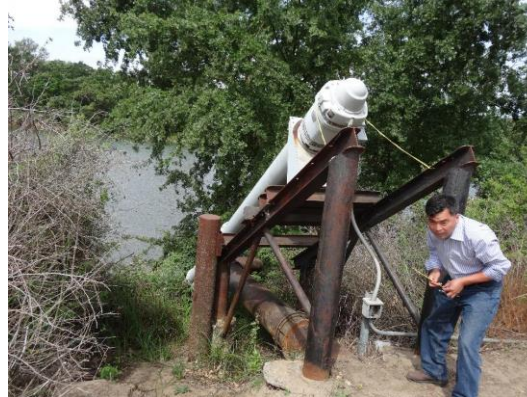
Photo 3 of 3 : UCIP\_SP\_2018\_14548\_23968.jpg

| UCIP Comments: - siphon breaker on the landward shoulder not found.- cracked road surface along the pipe alienment. Needs more investigations. | | | | | | |

WS- slant pump, pipe on steel piles.

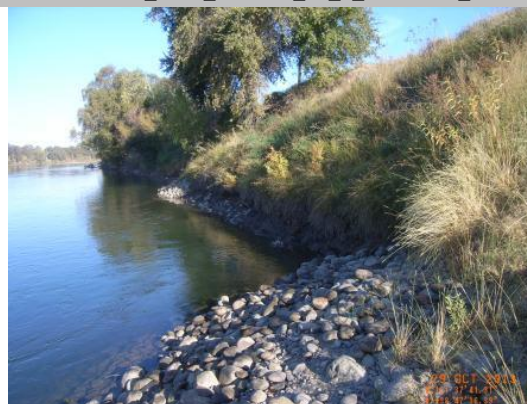
Photo 1 of 1 : SP\_2018\_RD1001\_38\_1\_20180302\_00001.jpg

| 1997- Deposits over top of cobble on the upper slope. 2000 - Old cobble site in poor shape; some toe retreat, but little change; steep bank. 2010 - Site extended upstream due to new toe erosion. 2012 - Minor new erosion at toe, new slumping, animals holes and cracks observed. 2015: No observed changes. [2015 Site ID: FHR_0-6_L] | | | | | |

USACE 2013 Photo #1

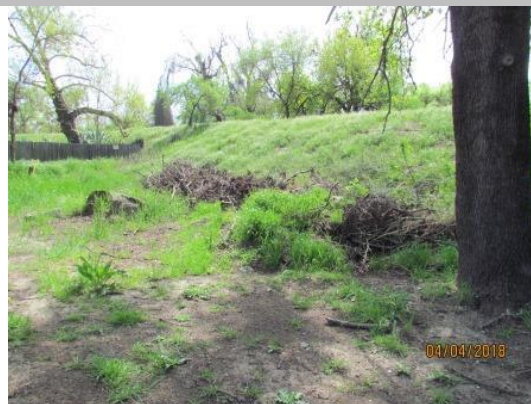
Photo 1 of 1 : SP\_2018\_RD1001\_38\_53\_20180411\_00100.jpg

View looking downstream landside of pruning's on levee toe, Spring 2018.

| Remove pruning's from levee toe, Spring 2018. | | | | | |

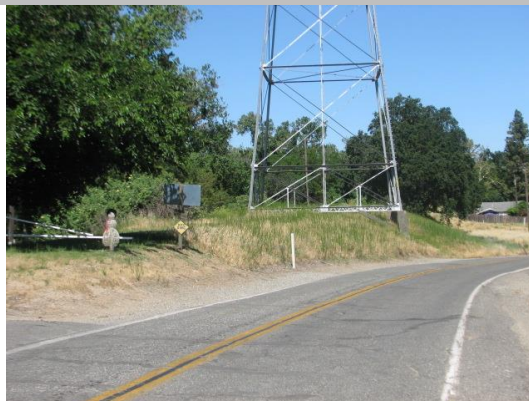
Photo 1 of 2 : SP\_2018\_RD1001\_38\_25\_20180302\_00014.jpg

A short section of the levee has limited access. Spring 2013

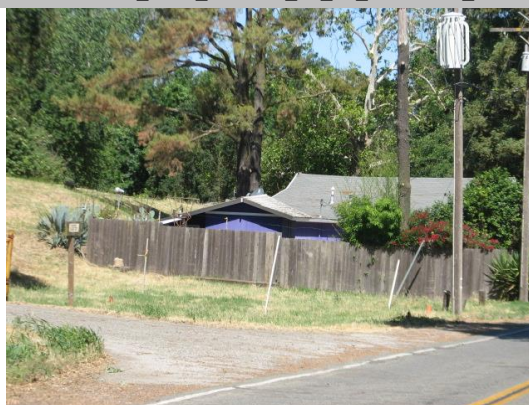
Photo 2 of 2 : SP\_2018\_RD1001\_38\_25\_20180302\_00015.jpg

A building is at the toe of the levee. Spring 2013

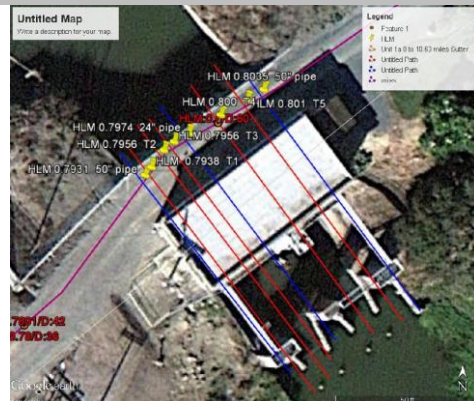
Photo 1 of 3 : UCIP\_SP\_2018\_14393\_23697.jpg

| FS_ID:14393<br>DS_ID:22610<br>EP_NO: N/A<br>Repair Type: Non-Urgent<br>Crossing Status: Found<br>UCIP Comments: - needs repair of concrete piers on waterside. Rebar exposed from the pier. Even though this pier is functionally not linked to the pipe, it needs repair.<br>FIELD_STRUCT_DESC: 5 of 8: 24-inch reinforced concrete drainage discharge pipe through the levee, 25 feet below the crown. Five 60-inch by 84-inch reinforced concrete drainage tunnels through the levee, 25 feet below the crown. One tunnel has a 60-inch pump installed inside and is gated on the waterside (WS) end. Two 50-inch steel drainage discharge pipes through the levee, 25 feet below the crown. All tunnels and pipes are gated. Concrete headwall and railing along the landside (LS). (Reclamation District No. 1001). [Additional Reference(s): DWR Levee Log, 1993].<br>FS Date: 5/15/2013 | | | | | | |

Location of pipes and tunnels. 24-inch steel pipe located at 5th from the left.

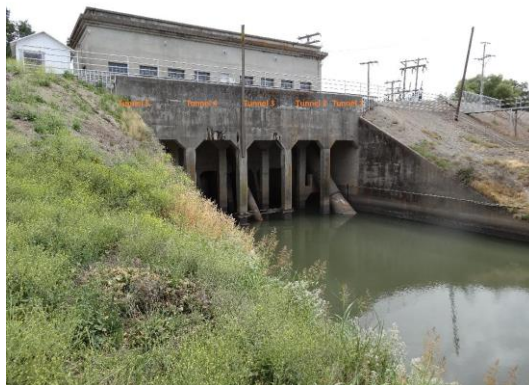
Photo 2 of 3 : UCIP\_SP\_2018\_14393\_23696.jpg

LS- Drainage structure with tunnels, pipes and pump house. Tunnel 1 at far right and tunnel 5 at far left. The pipe is located inside tunnel 3.

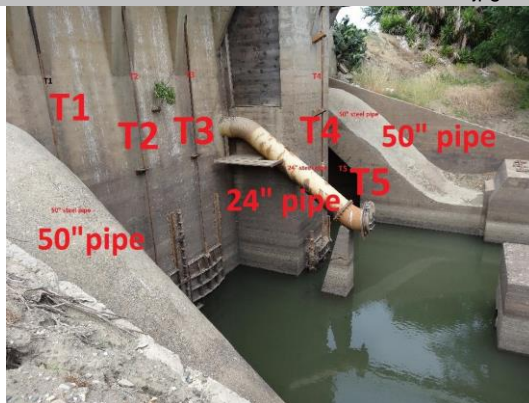
Photo 3 of 3 : UCIP\_SP\_2018\_14393\_23799.jpg

WS- three steel pipes inside tunnel. Fifty inch pipes on left and right. Twenty four inch pipe in middle of the structure as shown.

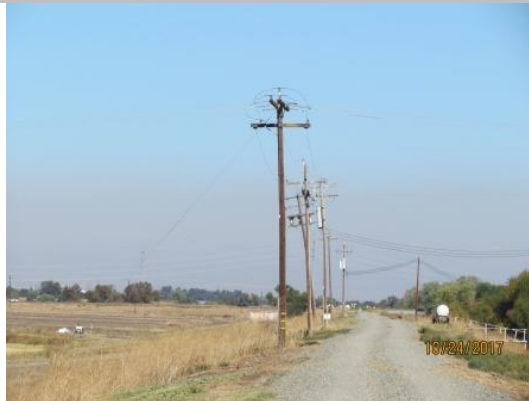
Photo 1 of 1 : SP\_2018\_RD1001\_39\_7\_20180302\_00004.jpg

View of poles on the landside shoulder looking downstream. Fall 2017.

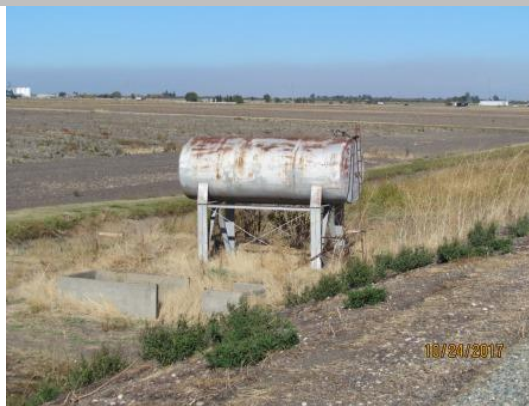
Photo 1 of 1 : SP\_2018\_RD1001\_39\_10\_20180302\_00009.jpg

| Fuel tank at landside levee toe. | | | | | |

View of poles on the landside shoulder looking downstream. Fall 2017.

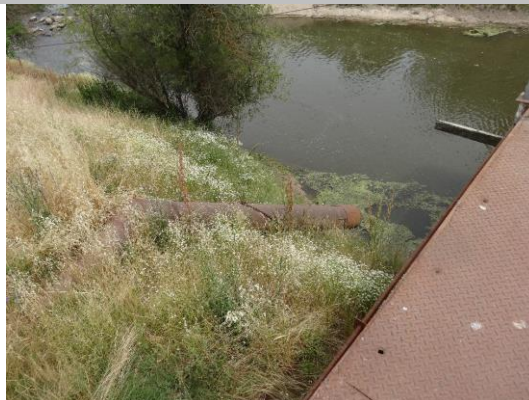
Photo 2 of 3 : UCIP\_SP\_2018\_14486\_23912.jpg

WS- abandoned pipe adjacent to pump station on stream bank.

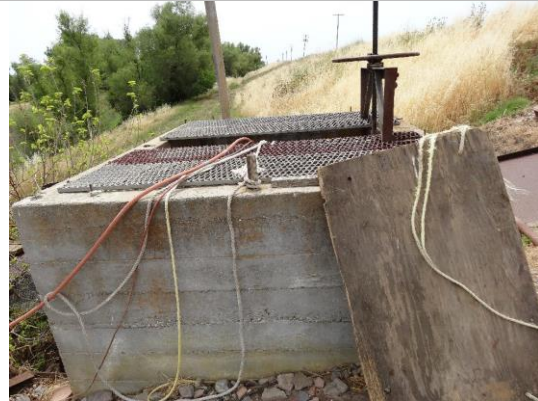
Photo 3 of 3 : UCIP\_SP\_2018\_14486\_23911.jpg

| cracked headwall on landside- working during field survey- | | | | | | |

WS- slide gate in concrete box on levee toe.

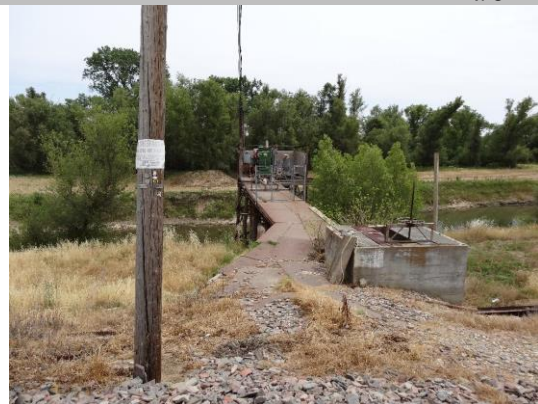
Photo 1 of 3 : UCIP\_SP\_2018\_14484\_23894.jpg

| FS_ID:14484<br>DS_ID:22595<br>EP_NO: 1896<br>Repair Type: Non-Urgent<br>Crossing Status: Found<br>UCIP Comments: - slide gate in concrete box on waterside levee toe.-<br>cracked headwall on landside- working during field survey<br>FIELD_STRUCT_DESC: *ABANDONED* 2 of 3: 20-inch asbestos<br>bonded corrugated metal irrigation discharge pipe through the levee,<br>2.13 feet below the crown. Three vertical pumps on a wooden piling<br>structure in the stream. Walkway to the pumps. Slide gate in a concrete<br>box on the waterside (WS). (Permit No. 1896, [permit missing]).<br>[Additional Reference(s): DWR Levee Log, 1993].<br>FS Date: 5/15/2013 | | | | | |

WS- overview of pump station, walkway, and slide gate in concrete box.

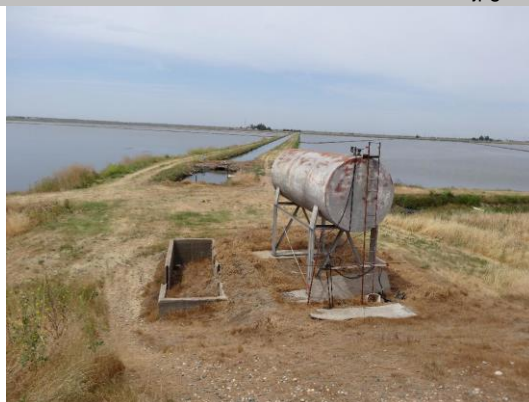
Photo 3 of 3 : UCIP\_SP\_2018\_14484\_23897.jpg

LS- overview of irrigation ditch on levee toe (top)

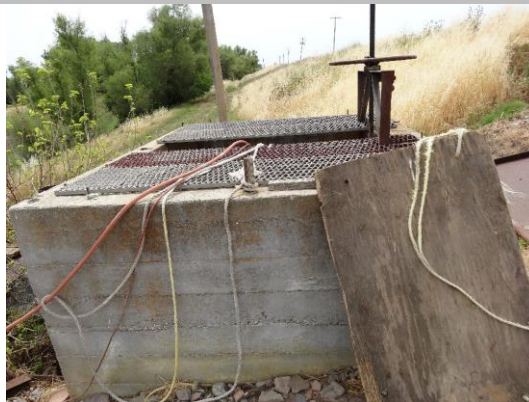
Photo 2 of 3 : UCIP\_SP\_2018\_14472\_23890.jpg

| FS_ID:14472<br>DS_ID:22613<br>EP_NO: 1896<br>Repair Type: Non-Urgent<br>Crossing Status: Found<br>UCIP Comments: - slide gate in concrete box on waterside levee toe.-<br>cracked headwall on landside- working during field survey<br>FIELD_STRUCT_DESC: *ABANDONED* 3 of 3: 30-inch asbestos<br>bonded corrugated metal irrigation discharge pipe through the levee,<br>2.13 feet below the crown. Three vertical pumps on a wooden piling<br>structure in the stream. Walkway to the pumps. Slide gate in a concrete<br>box on the waterside (WS). (Permit No. 1896, [permit missing])).<br>[Additional Reference(s): DWR Levee Log, 1993].<br>FS Date: 5/15/2013 | | | | | |

WS- slide gate in concrete box on levee toe

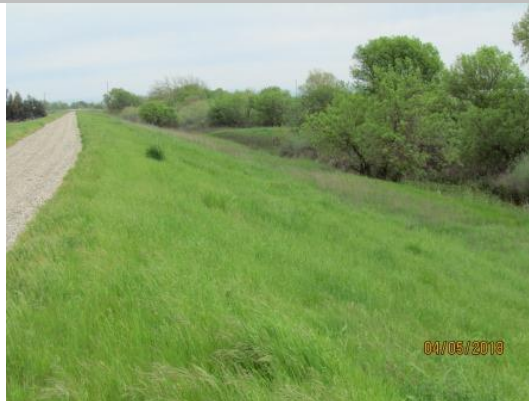
Photo 1 of 1 : SP\_2018\_RD1001\_40\_16\_20180411\_00040.jpg

| Annual vegetation has grown back too tall and needs to be maintained for visibility, Spring 2018. | | | | | |

View looking upstream waterside of the annual vegetation that needs to be maintained for better visual inspection, Spring 2018.

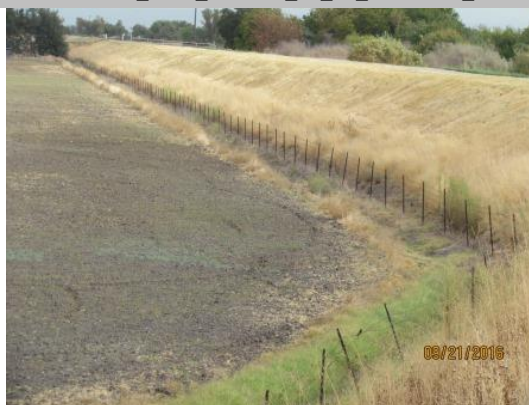
Photo 1 of 1 : SP\_2018\_RD1001\_40\_20\_20180302\_00010.jpg

| Fence along the landside levee toe. | | | | | |

View of fence along the landside levee toe looking upstream. Fall 2016.

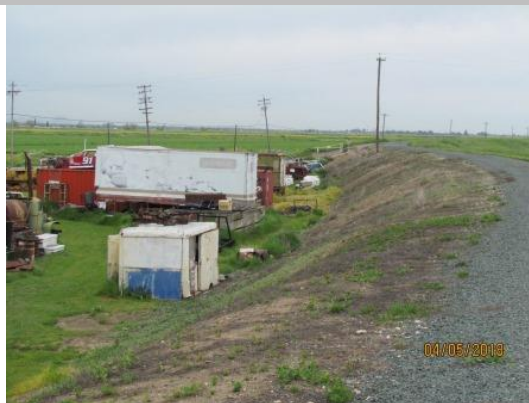
Photo 1 of 1 : SP\_2018\_RD1001\_40\_3\_20180411\_00043.jpg

View looking upstream of the equipment at the landside levee toe, Spring 2018.

| Remove equipment from levee toe, Spring 2018. | | | | | |

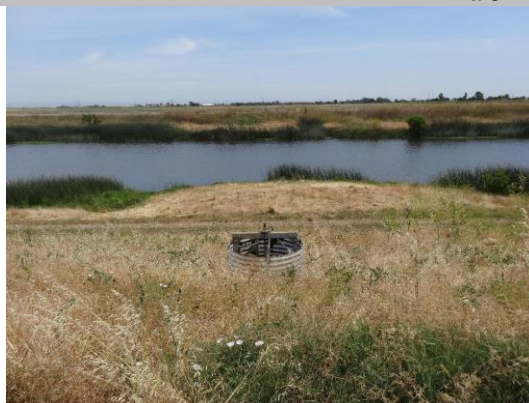
Photo 1 of 3 : UCIP\_SP\_2018\_14244\_23467.jpg

| FS_ID:14244<br>DS_ID:22617<br>EP_NO: N/A<br>Repair Type: Non-Urgent<br>Crossing Status: Found<br>UCIP Comments: - visible damage to pipe on opening at inlet due to high corrosion.- video inspection recommended.<br>FIELD_STRUCT_DESC: 36-inch corrugated metal gravity drainage pipe through the levee, 12.5 feet below the crown. Slide gate in a 48-inch corrugated metal pipe (CMP) riser on the waterside (WS) slope. Concrete headwall at the landside (LS) toe. Pipe crosses under the channel. [Additional Reference(s): DWR Levee Log, 1993].<br>FS Date: 5/15/2013 | | | | | |

WS- slide gate in CMP riser on levee slope.

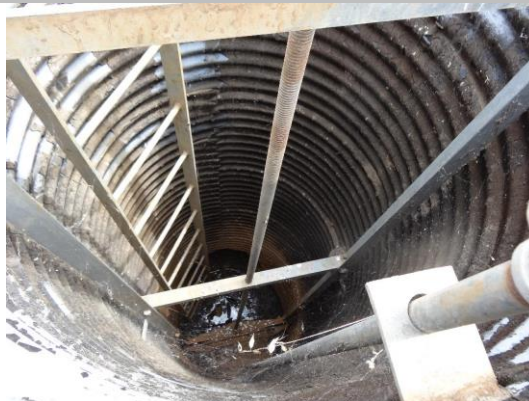
Photo 2 of 3 : UCIP\_SP\_2018\_14244\_23466.jpg

WS- slide gate, air vent pipe in CMP riser on levee slope.

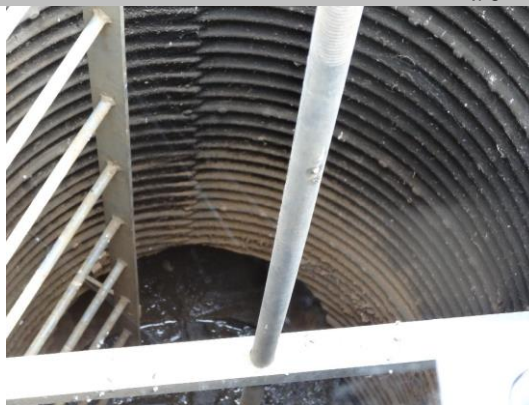
Photo 3 of 3 : UCIP\_SP\_2018\_14244\_23465.jpg

WS- pipe opening visible inside CMP riser.

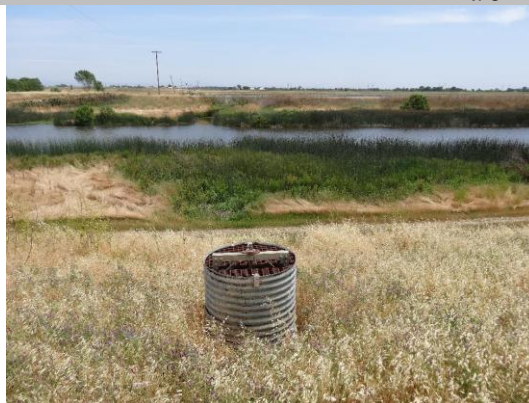
Photo 1 of 3 : UCIP\_SP\_2018\_14223\_23445.jpg

| FS_ID:14223<br>DS_ID:22616<br>EP_NO: N/A<br>Repair Type: Non-Urgent<br>Crossing Status: Found<br>UCIP Comments: - pipe burried/submerged on LS- needs cleaning of LS pipe end opening.<br>FIELD_STRUCT_DESC: 24-inch corrugated metal gravity drainage pipe through the levee, 15.5 feet below the crown. Slide gate in a 36-inch corrugated metal pipe (CMP) riser on the waterside (WS) slope. Concrete headwall at the landside (LS) toe. Pipe crosses under the channel. [Additional Reference(s): DWR Levee Log, 1993].<br>FS Date: 5/15/2013 | | | | | |

WS- slide gate in CMP riser on levee slope.

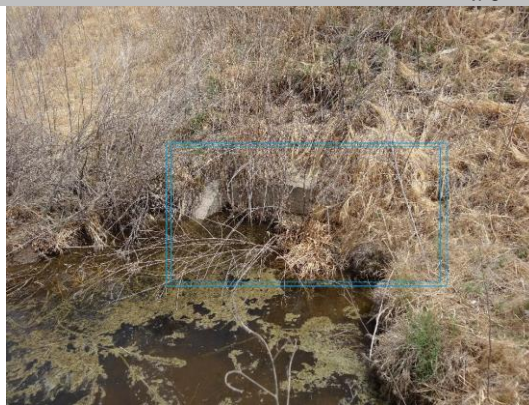
Photo 2 of 3 : UCIP\_SP\_2018\_14223\_23444.jpg

LS- concrete wing wall on levee toe

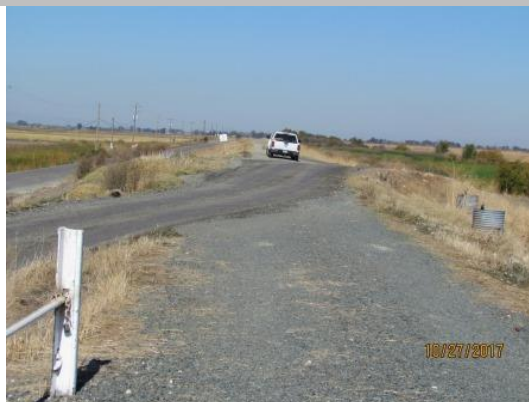
Photo 1 of 1 : SP\_2018\_RD1001\_40\_8\_20180302\_00004.jpg

| Crown where there is cross traffic. Monitor this area and fix as needed. | | | | | |

View of crown where there is cross traffic looking upstream. Monitor this area and fix as needed, Fall 2017.

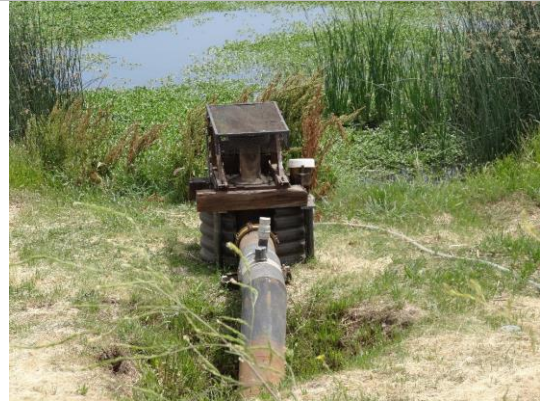
Photo 1 of 3 : UCIP\_SP\_2018\_50692\_23427.jpg

FS\_ID:50692  
DS\_ID:22622  
EP\_NO: 12208  
Repair Type: Urgent  
Crossing Status: Found  
UCIP Comments: 07/13/2016 Depression on WS berm has been backfilled, but the cause of the erosion was not addressed to my knowledge. As such, pipe integrity problem may still exist. Vegetation growth surrounds pipe on WS berm, in strike contrast to dry grass away from pipe alignment. This could be due to channel draining toward the pipe, or an indication of pipe leakage. (K. Fazel - UCIP)05/15/2013:- large pit at pipe daylight on WS berm, may be due to pipe leakage.- siphon breaker on LS shoulder not found. (P. Amatya - DWR)  
FIELD\_STRUCT\_DESC: 16-inch steel irrigation discharge pipe through the levee, 3 feet below the crown. 16-inch low-lift pump in the channel with a 1-inch electrical line also penetrating the levee to the power pole off the landside (LS) toe. 36-inch corrugated metal pipe (CMP) riser on the bank. Vent on the LS shoulder. Siphon breaker/vent on the apex of the pipe near the waterside (WS) pump. Standpipe off the LS toe. Pipe used seasonally only in the absence of groundwater, as per District President Joe Henderson. (16-inch irrigation pipe and 16-inch low-lift pump authorized under Permit No. 12208, 1977 - Thomas A. Cuguet).

WS- pump and pipe on river bank

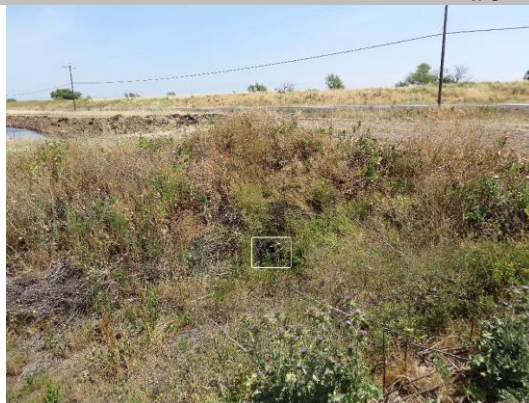
Photo 2 of 3 : UCIP\_SP\_2018\_14167\_23395.jpg

| FS_ID:14167<br>DS_ID:22630<br>EP_NO: N/A<br>Repair Type: Non-Urgent<br>Crossing Status: Found<br>UCIP Comments: - pipe opens in irrigation ditch on landside.-<br>vegetation cleaning on LS pipe opening.<br>FIELD_STRUCT_DESC: 24-inch corrugated metal gravity drainage pipe<br>through the levee, 12 feet below the crown. Slide gate in a 36-inch<br>corrugated metal pipe (CMP) riser on the waterside (WS) slope.<br>Concrete headwall at the landside (LS) toe. Pipe crosses under the<br>channel. [Additional Reference(s): DWR Levee Log, 1993].<br>FS Date: 5/15/2013 | | | | | | |

LS- CMP opens in irrigation ditch.

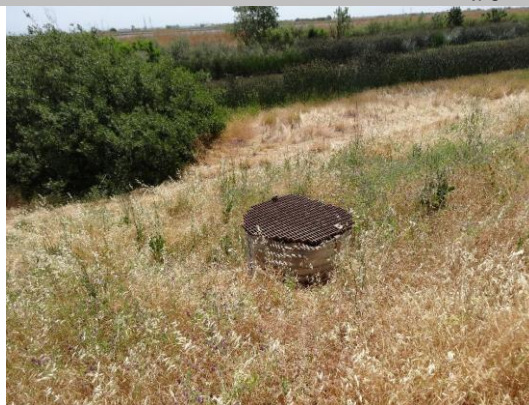
Photo 3 of 3 : UCIP\_SP\_2018\_14167\_23397.jpg

WS- slide gate in CMP riser on levee slope

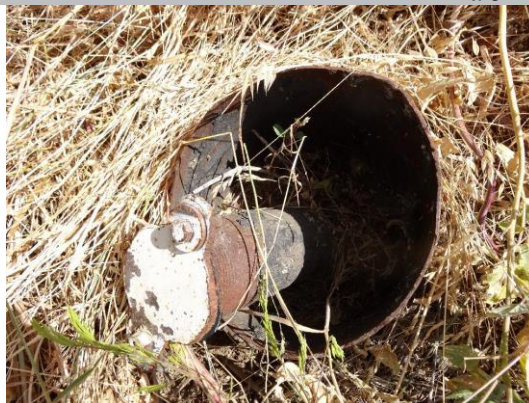
Photo 1 of 2 : UCIP\_SP\_2018\_13523\_22121.jpg

| FS_ID:13523<br>DS_ID:22619<br>EP_NO: N/A<br>Repair Type: Non-Urgent<br>Crossing Status: Found<br>UCIP Comments: - needs filling/plugging gap between 4-inch and 10-inch pipes.<br>FIELD_STRUCT_DESC: 1 of 2: Capped 4-inch steel irrigation pipe sleeved through a 10-inch steel pipe, at an unknown depth. Pipe exposed just off the top of the waterside (WS) slope. [Additional Reference(s): DWR Levee Log, 1993].<br>FS Date: 5/15/2013 | | | | | |

WS- a 4-inch steel pipe sleeved through 10-inch steel pipe.

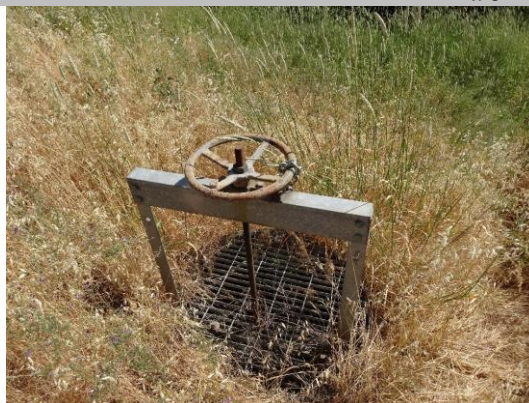
Photo 1 of 3 : UCIP\_SP\_2018\_41724\_22034.jpg

| FS_ID:41724<br>DS_ID:22618<br>EP_NO: N/A<br>Repair Type: Non-Urgent<br>Crossing Status: Found<br>UCIP Comments: - damaged head/wing wall in inlet structure.<br>FIELD_STRUCT_DESC: 30-inch corrugated metal gravity irrigation pipe through the levee, 15.9 feet below the crown. Slide gate in a 36-inch corrugated metal pipe (CMP) riser on the waterward slope. Pipe discharges into a large irrigation ditch on the west side of Pacific Avenue. (Joplin and South Sutter Water District). [Additional Reference(s): DWR Levee Log, 1993].<br>FS Date: 5/15/2013 | | | | | |

WS- slide gate in CMP riser.

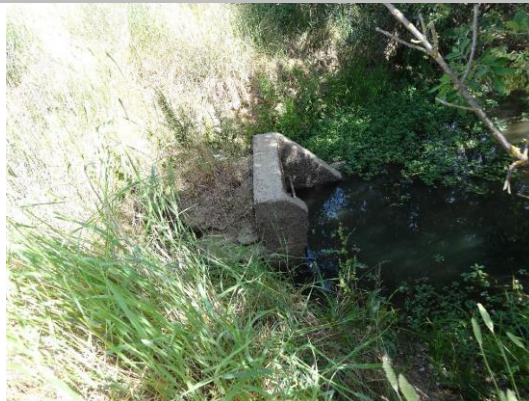
Photo 2 of 3 : UCIP\_SP\_2018\_41724\_22033.jpg

| UCIP Comments: - damaged head/wing wall in inlet structure. | | | | | | |

WS- inlet wing wall with trashrack

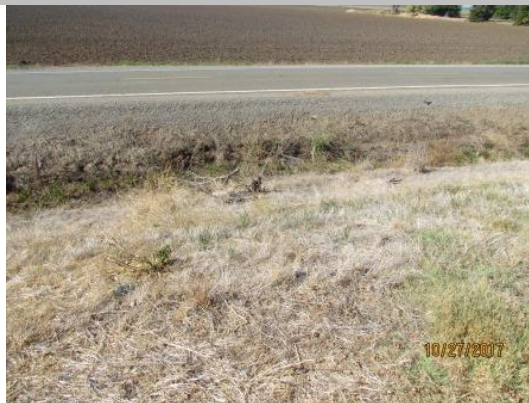
Photo 1 of 1 : SP\_2018\_RD1001\_40\_22\_20180302\_00011.jpg

View of a stump at the landside levee toe. Fall 2017.

| A stump at the landside levee toe needs to be removed, Fall 2017. | | | | | |

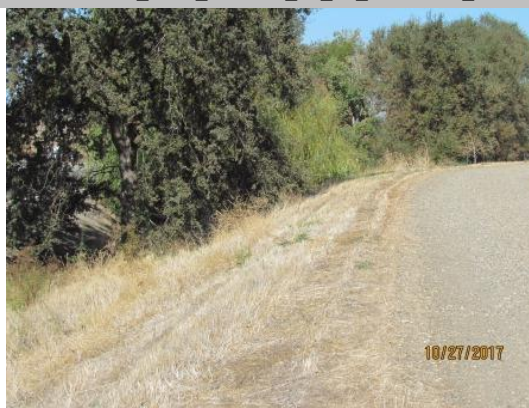
Photo 1 of 1 : SP\_2018\_RD1001\_40\_17\_20180302\_00006.jpg

View looking upstream landside at trees that need to be trimmed for access and visibility, Fall 2017.

| Trim tree limbs for access and visibility, Fall 2017. | | | | | |

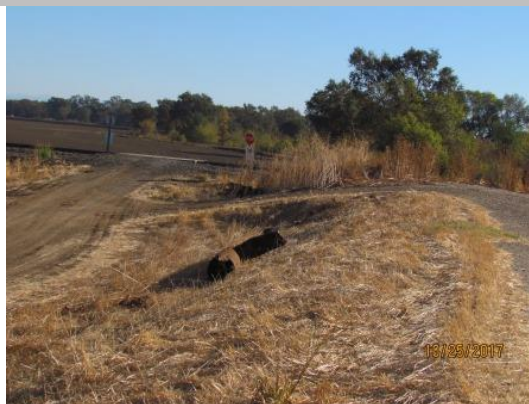
Photo 1 of 2 : SP\_2018\_RD1001\_40\_24\_20180302\_00012.jpg

| Old peace of pipe lying on landside levee slope. | | | | | |

View of an old piece of pipe lying on landside levee slope looking upstream. Fall 2017.
